**DANVERS RIVER BASIN
BEVERLY, MASSACHUSETTS**

**SHOE POND DAM
MA 00183**

PHASE I INSPECTION REPORT NATIONAL DAM INSPECTION PROGRAM

SEPTEMBER 1979

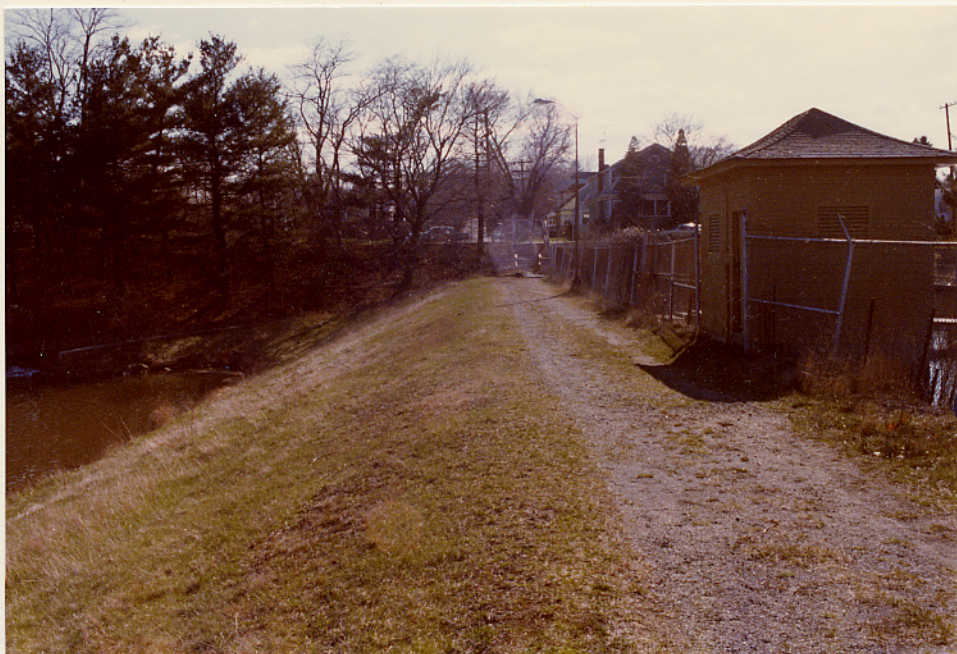
NO. 1 DAM CREST AND DOWNSTREAM EMBANKMENT

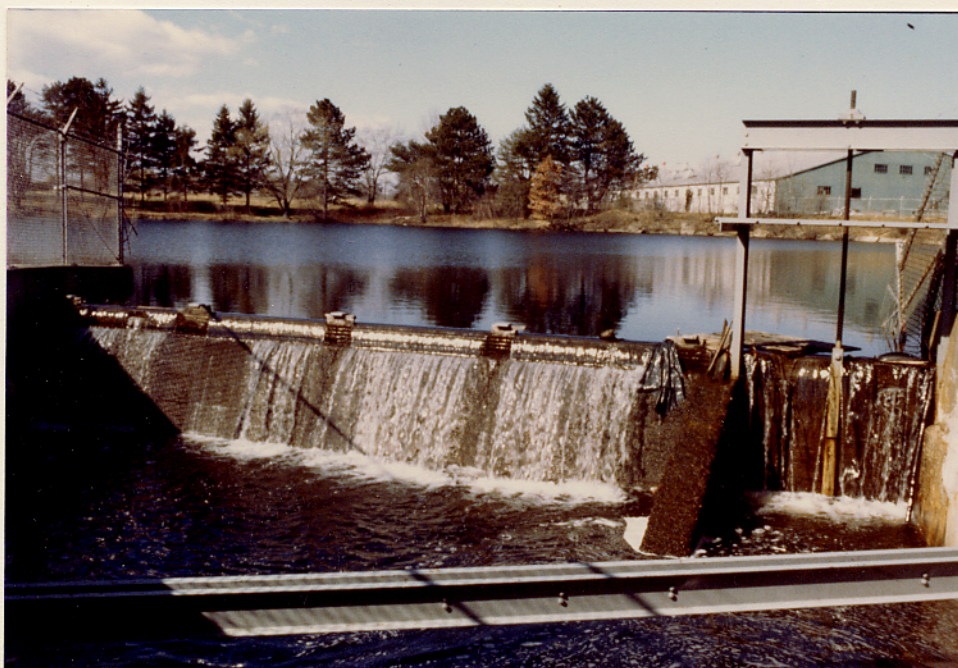
NO. 2 SHARP CRESTED WEIR AND LOW LEVEL GATE

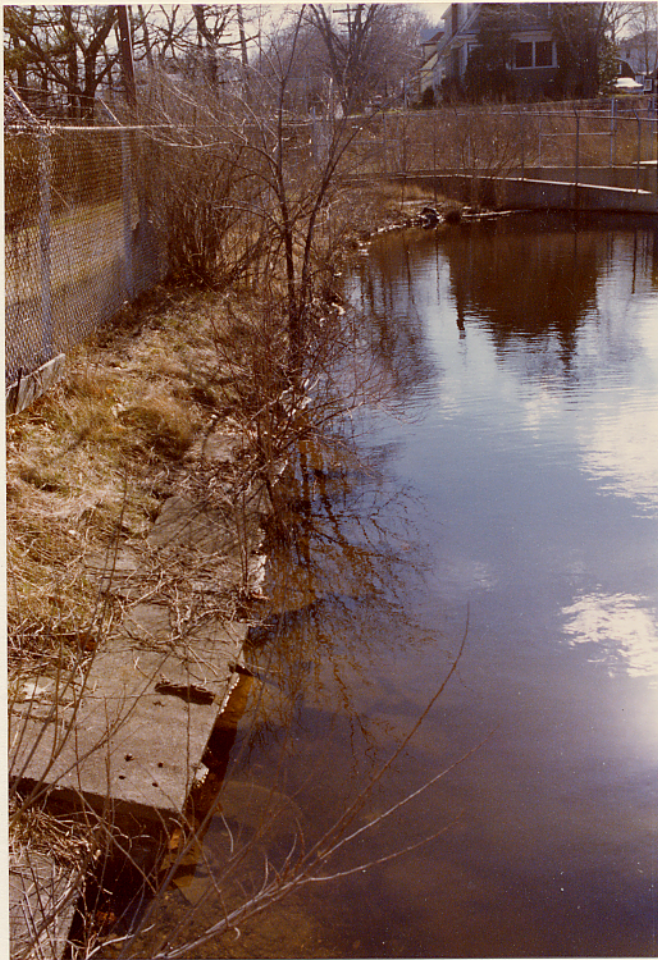
The main dam is in fair condition. The upstream slope, 2:1 (horizontal to vertical) is riprapped to within 2 feet of the crest of the dam (see Photo No. 3). Some of the riprap is missing and, in one area, it has slipped down the slope. There are several random concrete slabs at the top of the riprap in the middle of the dam.

NO. 3 UPSTREAM RIPRAP

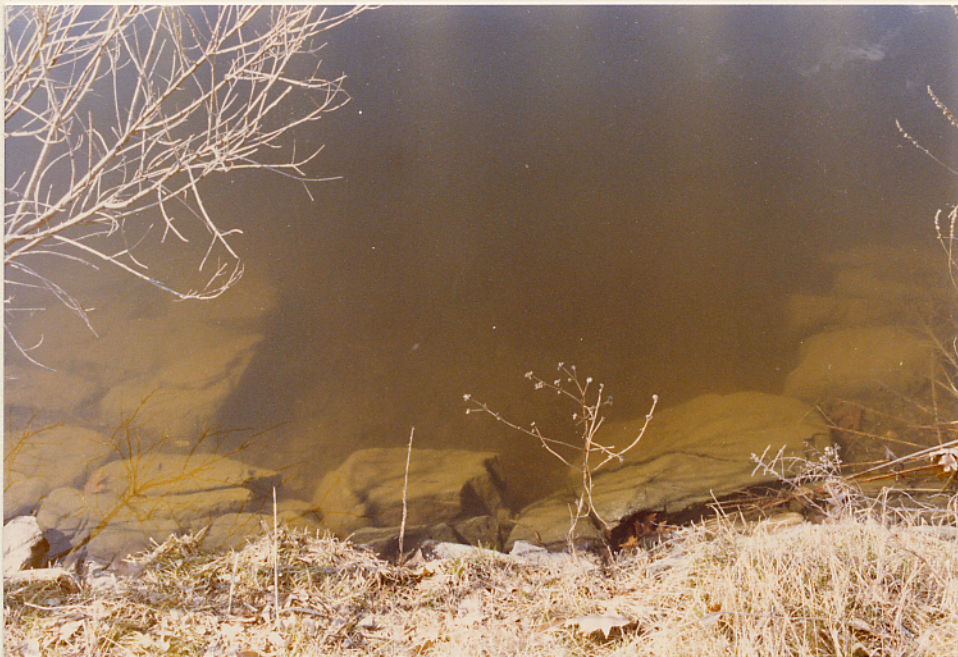
NO. 4 MISSING RIPRAP ON UPSTREAM CREST OF DAM

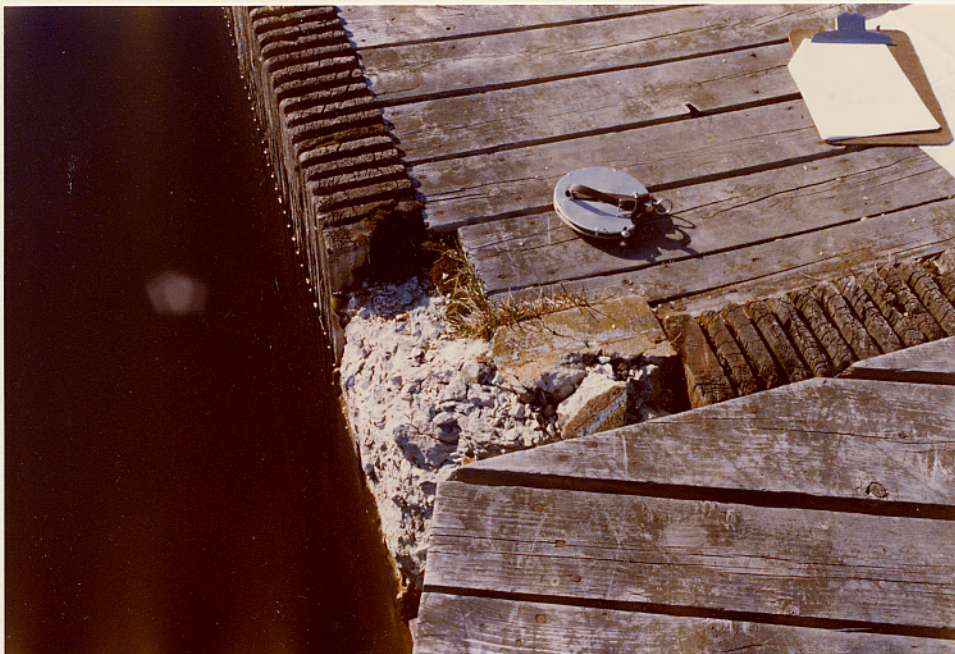
The valves to the 14-inch intake pipe are kept open and are not operated. These valves are located in the gatehouse which is kept locked. Concrete supporting the pier leading to the intake pipe is in poor condition. The wooden screen structure at the discharge pipe is rotting.

**NO. 5 DETERIORATED CONCRETE SUPPORT
AT PIER AND PLATFORM – 14 INCH INTAKE**

- (8) Repair the deteriorated concrete on the columns supporting the pier out to the 14-inch intake.
- (9) Conduct a program of monthly maintenance inspections of the dam and appurtenances. This should include monthly clearing of debris from the trash rack in the chute below the outlet works. Additional inspections should be conducted during and after severe storms. All repairs and maintenance should be undertaken in accordance with all applicable State regulations.

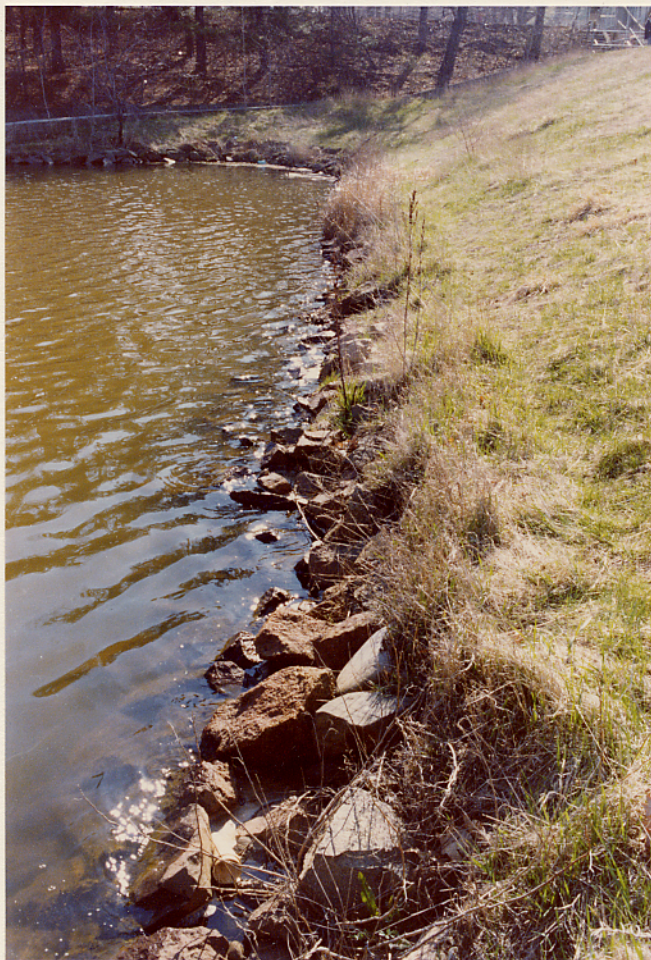
30 feet long. At the toe of the slope there is riprap extending out into the lower pond. This riprap was in good condition.

NO. 6 DOWNSTREAM RIPRAP

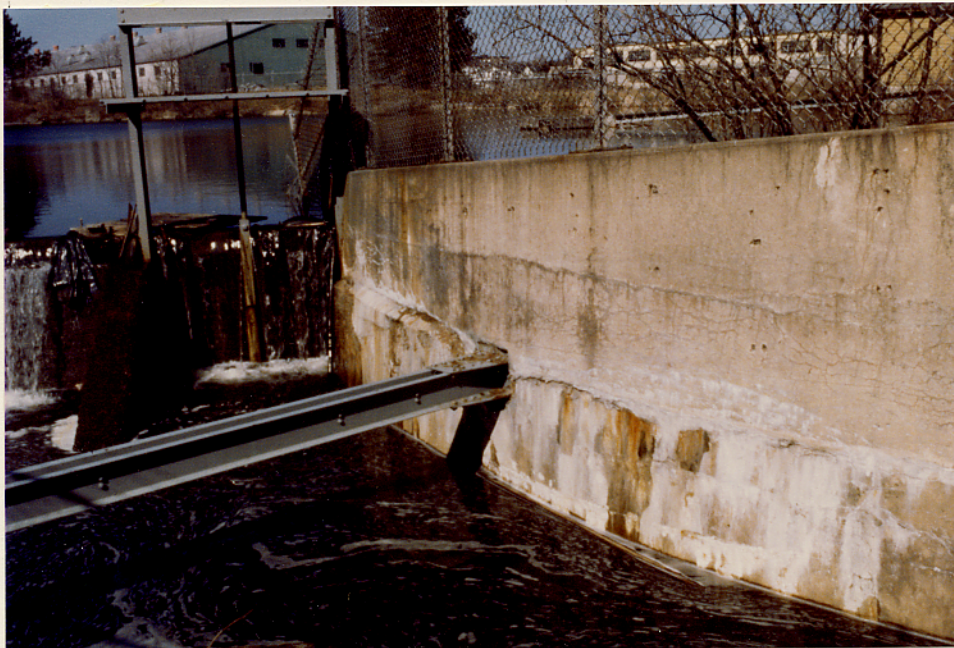
The chute has some localized wet areas and some severe spalling near the weir and low-level outlet (see photograph No. 7). The floor of the chute is also spalled at the downstream end for a length of 20 feet. Downstream of the weir, there are two I-beam compression struts to support the concrete walls of the chute. The concrete around the joints at all four locations is in poor condition. A trash rack is located on the upstream side of a foot bridge over the chute. The rack is in good condition, although it contains an accumulation of debris about 3 feet deep. There is one crack that extends across the floor and walls of the chute. This crack is located midway between the footbridge and the downstream end of the chute. Brush and trees are growing along the west side of the chute, and some branches are overhanging the chute.

NO. 7 LOW LEVEL GATE AND CHUTE COMPRESSION STRUT

- a. Operating and Maintenance Procedures. It is recommended that the Owner accomplish the following:
 - (1) Repair the concrete at the junction of the I-beam compression struts and the walls of the chute.
 - (2) Repair the spalled concrete on the walls and floor of the chute and repair the crack located below the trash rack.
 - (3) Repair the erosion and dislodged sections of fence on the crest of the dam.
 - (4) Replace riprap missing from the upstream face of the dam.
 - (5) Remove all the bushes on the crest of the dam and initiate selective clearing of trees and roots adjacent to the west side of the chute. Backfill where required with selected material.

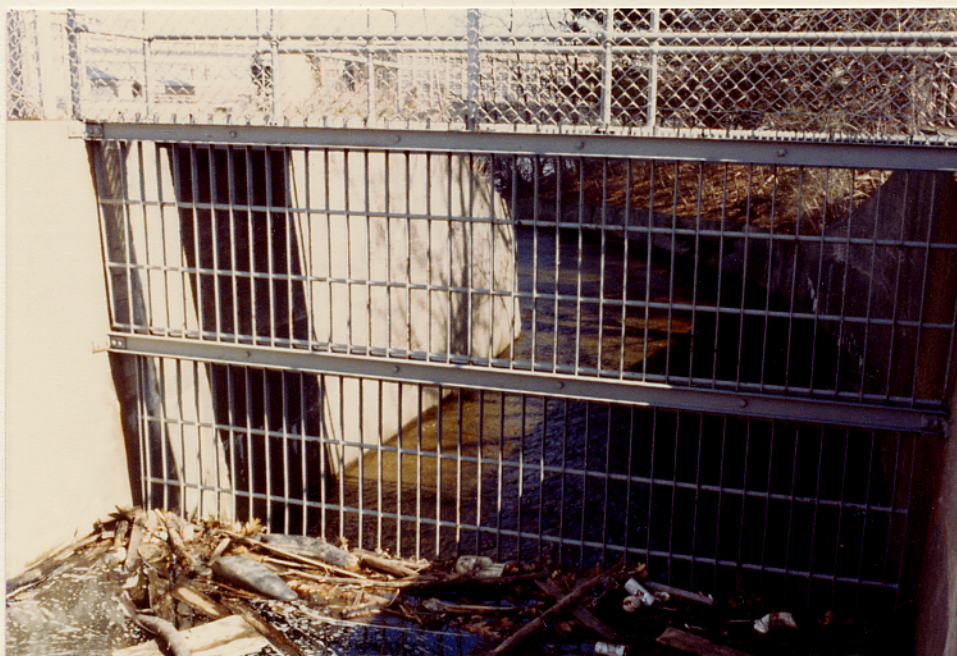
The concrete of the chute is spalled and cracked in places, and debris has piled up 2 to 3 feet deep at the trash rack. Trees and bushes are growing along the west side of the chute.

NO. 8 TRASH RACK AND CHUTE
